## DETERMINING THE SPRINGS OF TWO IMPORTANT RIVERS ON THE SERRAS DA JACOBINA MOUNTAINS, CHAPADA DIAMANTINA, BAHIA, BRAZIL

### DETERMINAÇÃO DAS NASCENTES DE DOIS IMPORTANTES RIOS NAS SERRAS DA JACOBINA, CHAPADA DIAMANTINA, BAHIA, BRASIL

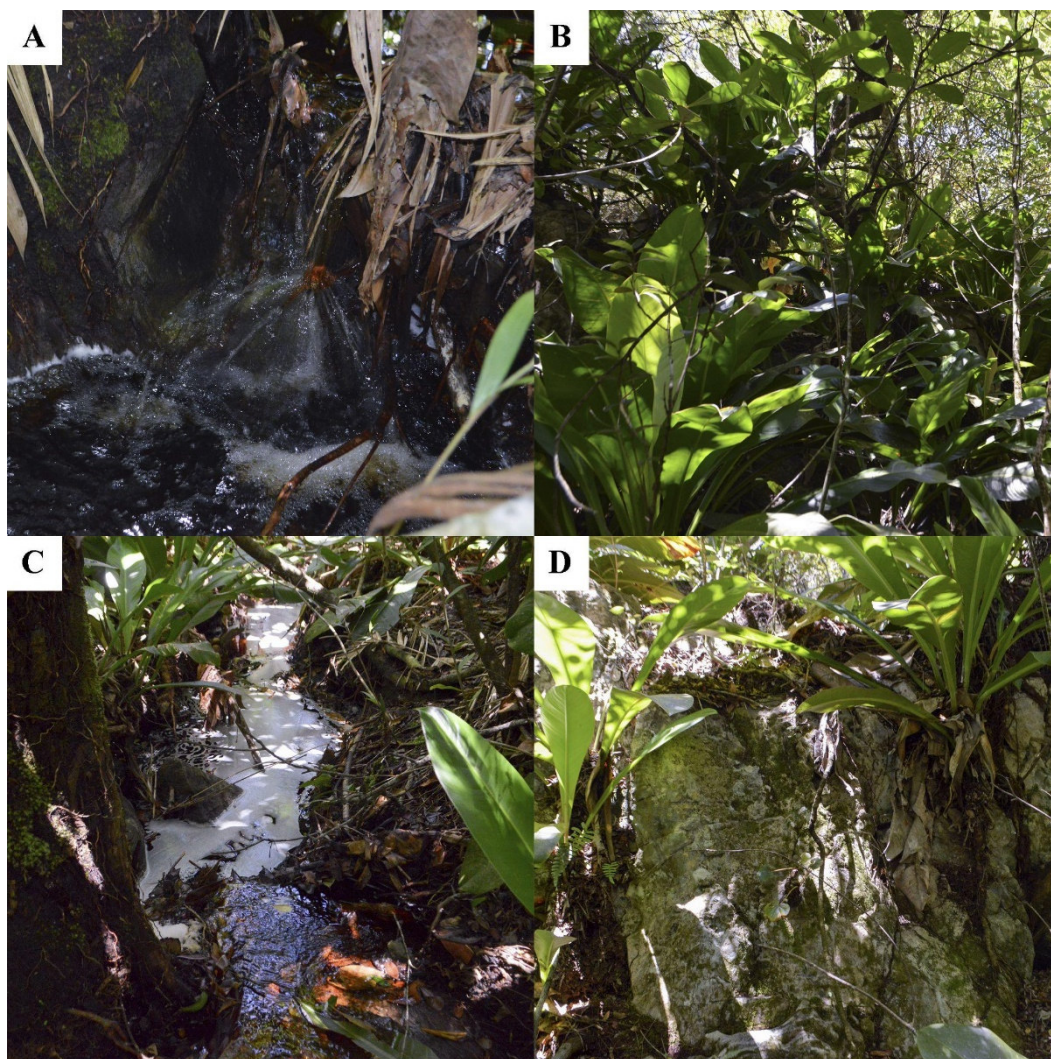
**FIGURE 3 (A-D).** Pictures of the E1/NR location. 3A: small waterfall of the Rio Fumaça river at the E1/NR location. 3B: vegetation at the E1/NR location. 3C: water and natural foam at the E1/NR location. 3D: the only marked feature at the E1/NR location, a large whitish rock.

Carvalho *et al.*, (2013) provided no pictures of the E1/NR area in their study, which makes it impossible to perform visual comparisons. However, upon reaching E1/NR (10°37'14.40"S 40°22'36.18"W) during the field expedition, the authors of this study found that the area by no means corresponded to a diffuse water spring. In fact, the Rio Fumaça flows quite strongly toward the south in that location. As suspected, that specific point was a deep valley with no traces of cattle, no open trail, and the only marked feature there was a large whitish rock. The ground view of the E1/NR location can be seen below in Figure 3. Therefore, these results challenge the data attributed to "E1" by Carvalho *et al.*, (2013) and instead reinforce the

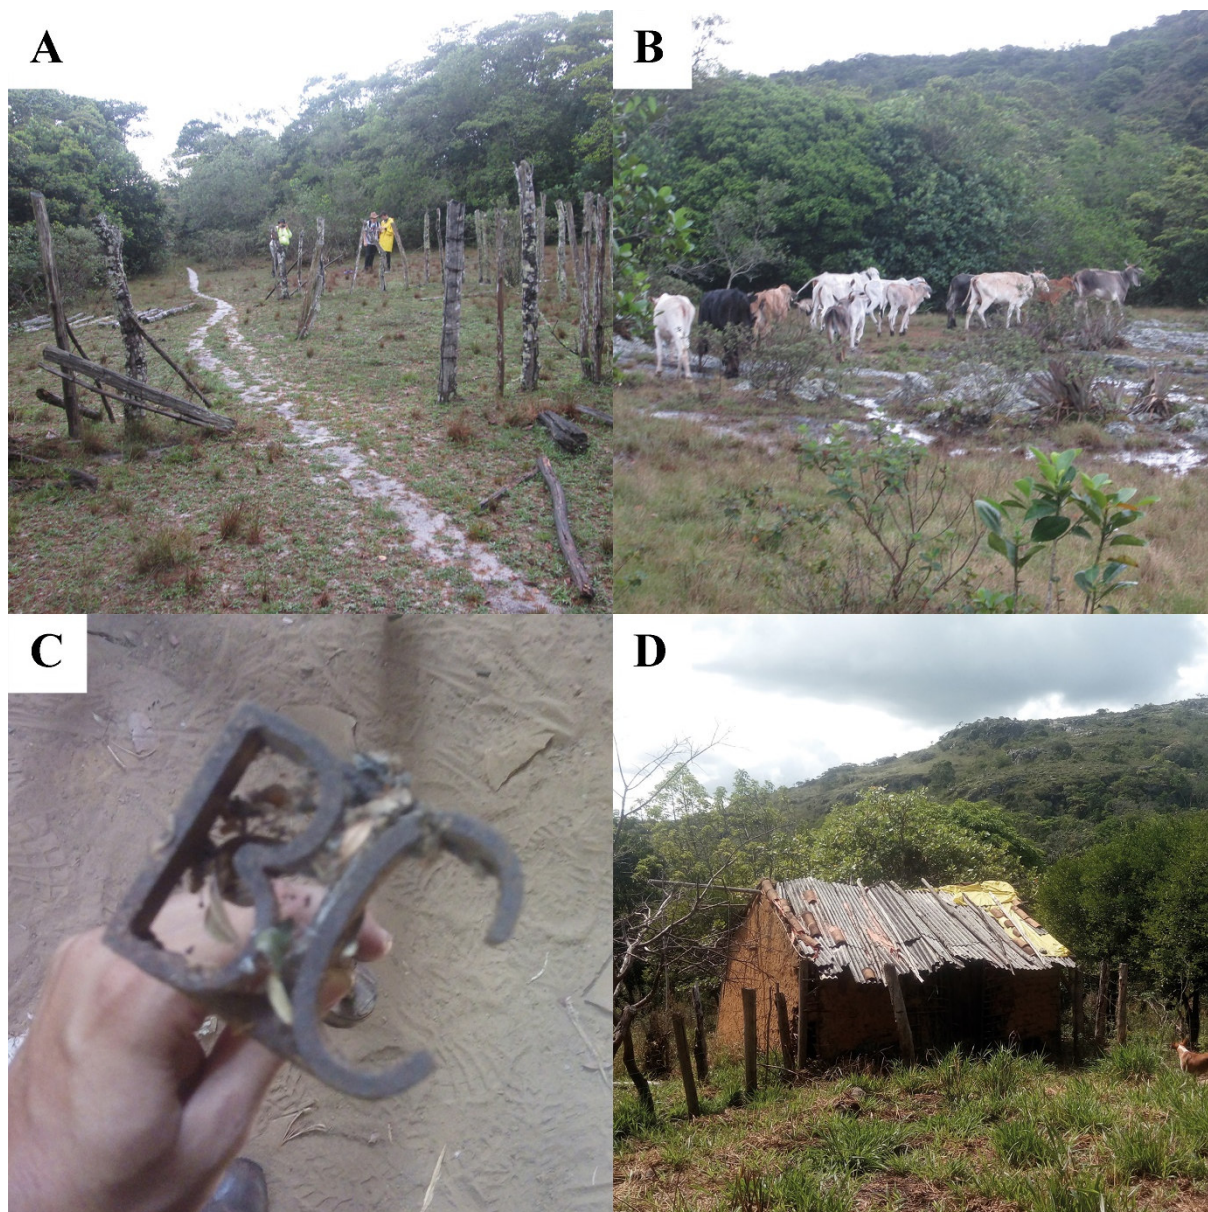
**FIGURE 7 (A-D).** Cattle raising on the Serra da Fumaça mountains. 7A: fenced areas used to store cattle like the one depicted here (10°37'25.89"S 40°22'58.77"W) are common all over the area. 7B: cattle herd roaming free near the northernmost water spring of the Rio Fumaça river. 7C: iron used to mark the cattle found outside the shack seen in Figure 7D. 7D: shack used by cattle keepers on the Serra da Fumaça.

The plateau tops of the Serra da Fumaça mountains are used for cattle raising by inhabitants of at least four neighboring municipalities: Campo Formoso, Antônio Gonçalves, Pindobaçu, Ponto Novo, and Mirangaba (MARQUES *et al.*, 2021). Whereas the cattle and deforestation represent dangers through the removal of natural vegetation and illegal fires set up to open new grazing sites, the cattle itself has the additional impact of compacting the soil, which is even more worrisome in open water spring areas (DIAS *et al.* 2022). Examples of the area's occupation by cattle raising can be seen below in Figure 7:

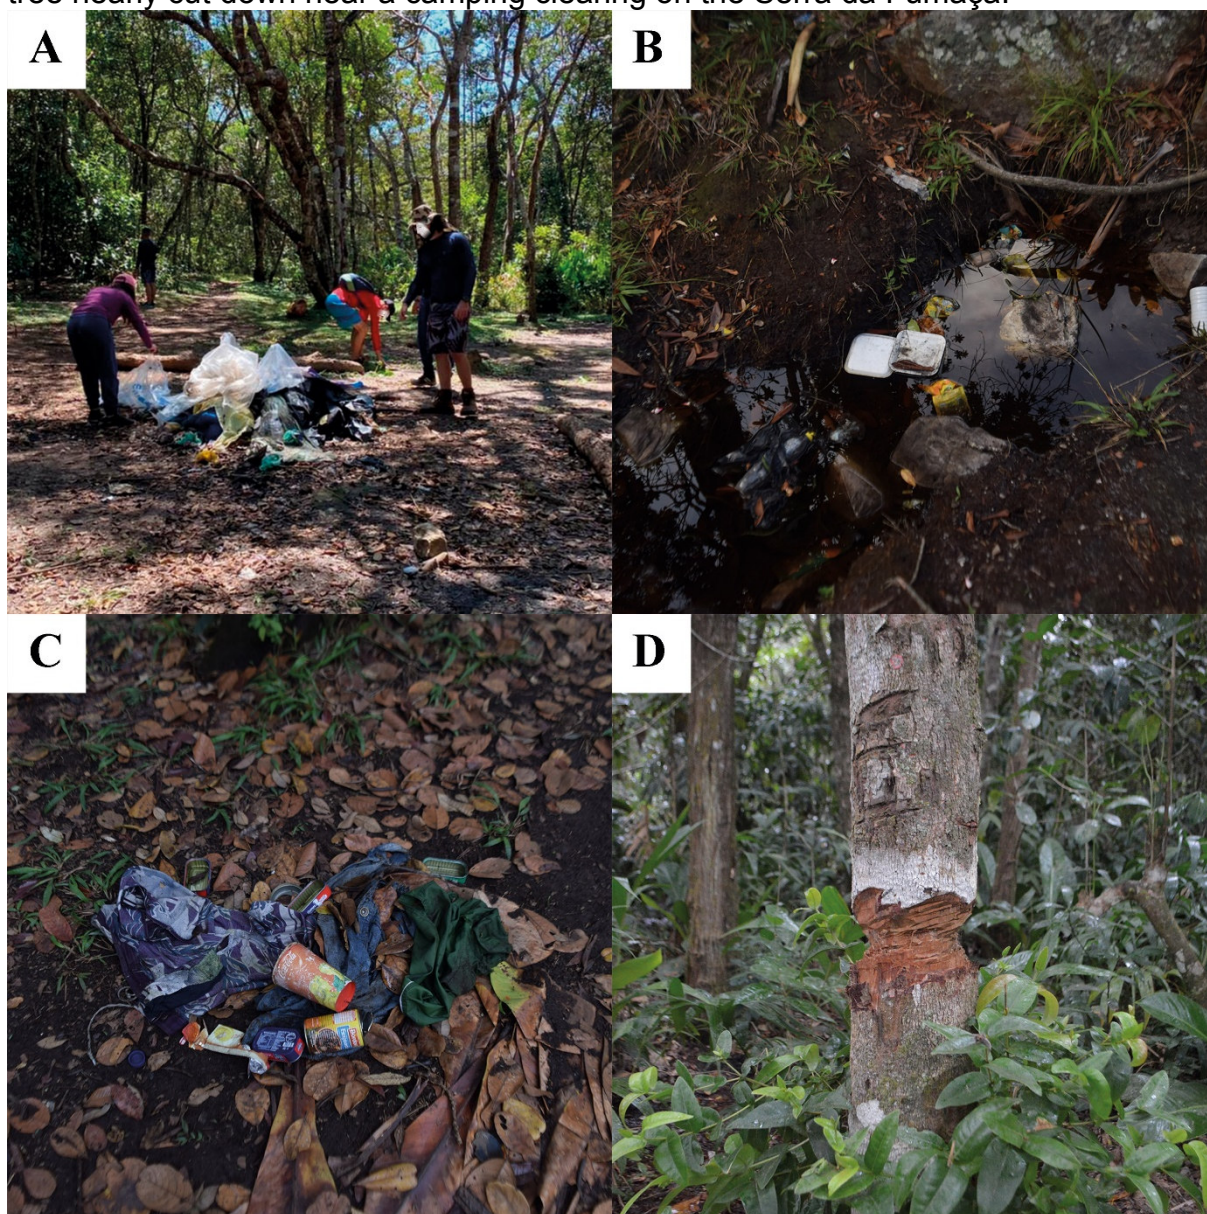
**FIGURE 8 (A-D).** 8A: garbage left by tourists being collected by volunteers on the Serra da Fumaça. 8B-C: waste left behind by tourists on the Serra da Fumaça. 8D: tree nearly cut down near a camping clearing on the Serra da Fumaça.

Moreover, the intensive and uncontrolled presence of tourists in the area has worsened the pollution of both soil and water, further compromising the conservation of the region (CARVALHO *et al.*, 2013). The trail of garbage left behind by tourists and their role in the devastation of the natural vegetation through the unnecessary removal of trees to widen clearings in the forest can be seen below in Figure 8.

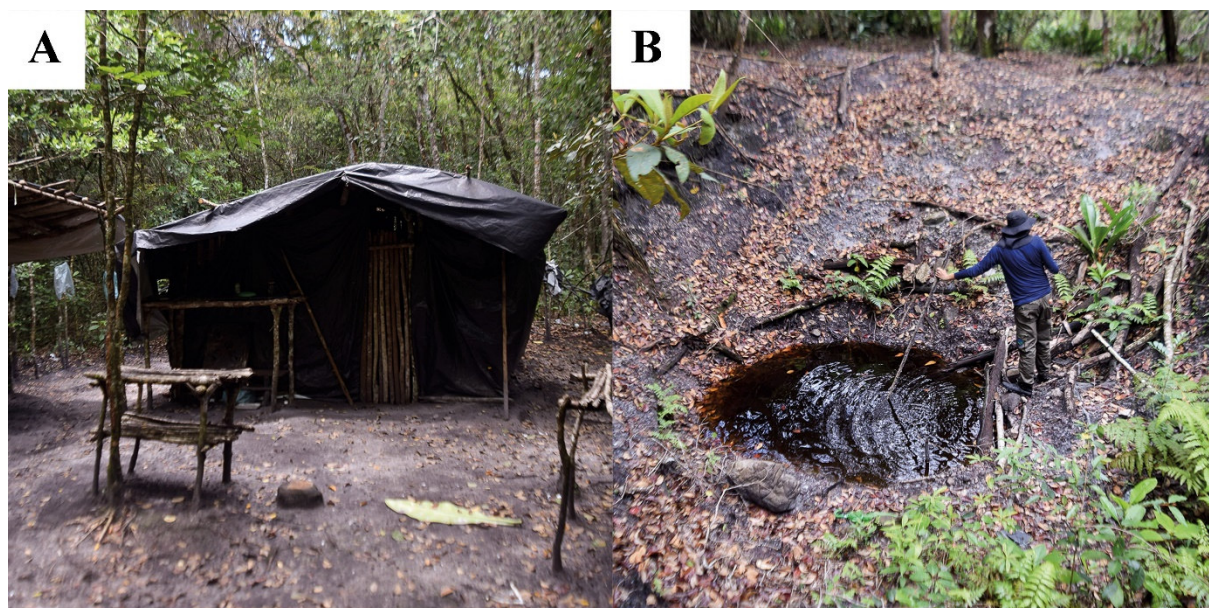
**FIGURE 10 (A-B).** 10A: Semi-permanent shelter used to host miners on the Serra da Fumaça. 10B: mining hole left behind by miners.

Further aggravating this scenario, while conducting this study, the group discovered the existence of previously unknown mining activities on the Serra da Fumaça mountains, even with the presence of semi-permanent dwellings built to host miners along remote valleys of the mountain, as seen in Figure 7. It should be noted that such dwellings are built through deforestation, both to clear the area and to obtain raw material used to build the shelters. Then, after the area dug to search for minerals is exhausted, holes such as the one seen below in Figure 10 are simply left behind.

According to the Brazilian Federal Law no. 11,685, of June 2, 2008, which institutes the Miner's Statute, mining activities can only occur after the granting of mining rights by the competent authorities, without which any extraction is considered illegal and miners are not allowed to commercialize any extracted minerals. The same law also establishes that miners are required to recover the areas degraded by their activities, in addition to observing other local regulations (BRASIL, 2008). Therefore, one cannot say that the mining activities occurring on the Serra da Fumaça are either legal or illegal. Nevertheless, this report should serve as an alert to the local authorities regarding the need to regulate and monitor this activity in the area.

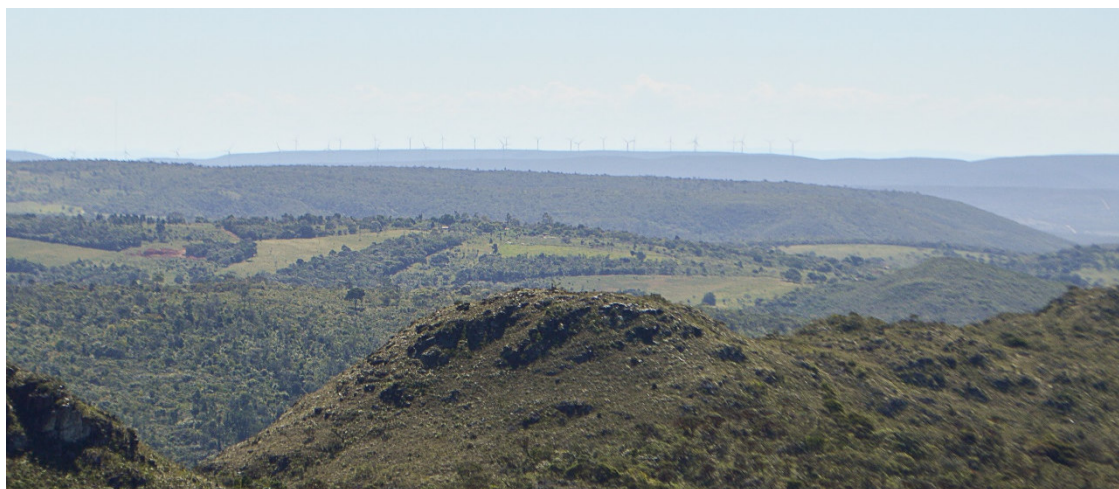
**FIGURE 12.** View from the western side of the Serra da Fumaça mountains depicting many wind towers on the horizon and deforested areas used for farming and grazing.

Another grave concern is related to the expansion of wind parks, which harness wind power to convert mechanical energy into electrical energy. Although with a proposal of sustainability through the production of clean energy, the construction of such wind parks drastically reduces green areas, threatens the local fauna and flora, negatively impacts the mountain environments where they are installed, and contributes to the expansion of mining, deforestation, and illegal fires (MARQUES *et al.*, 2021). The Serra da Fumaça mountains fare no better in this regard. In fact, from the western side of the mountain it is possible to witness in first hand numberless wind towers increasingly closer to the study area of the present manuscript, in addition to various and vast areas already deforested for farming and grazing purposes. The view from the western side of the mountain can be seen below in Figure 12.
